## Collapse-resisting mechanisms of planar trusses following sudden member loss

Yan, S, Zhao, X & Lu, Y 2017, 'Collapse-resisting mechanisms of planar trusses following sudden member loss', *Journal of Structural Engineering*, vol. 143, no. 9, 04017114. [https://doi.org/10.1061/\(ASCE\)ST.1943-541X.0001849](https://doi.org/10.1061/(ASCE)ST.1943-541X.0001849)

Shen Yan<sup>1</sup>, Xianzhong Zhao<sup>2</sup>, Yong Lu<sup>3</sup>

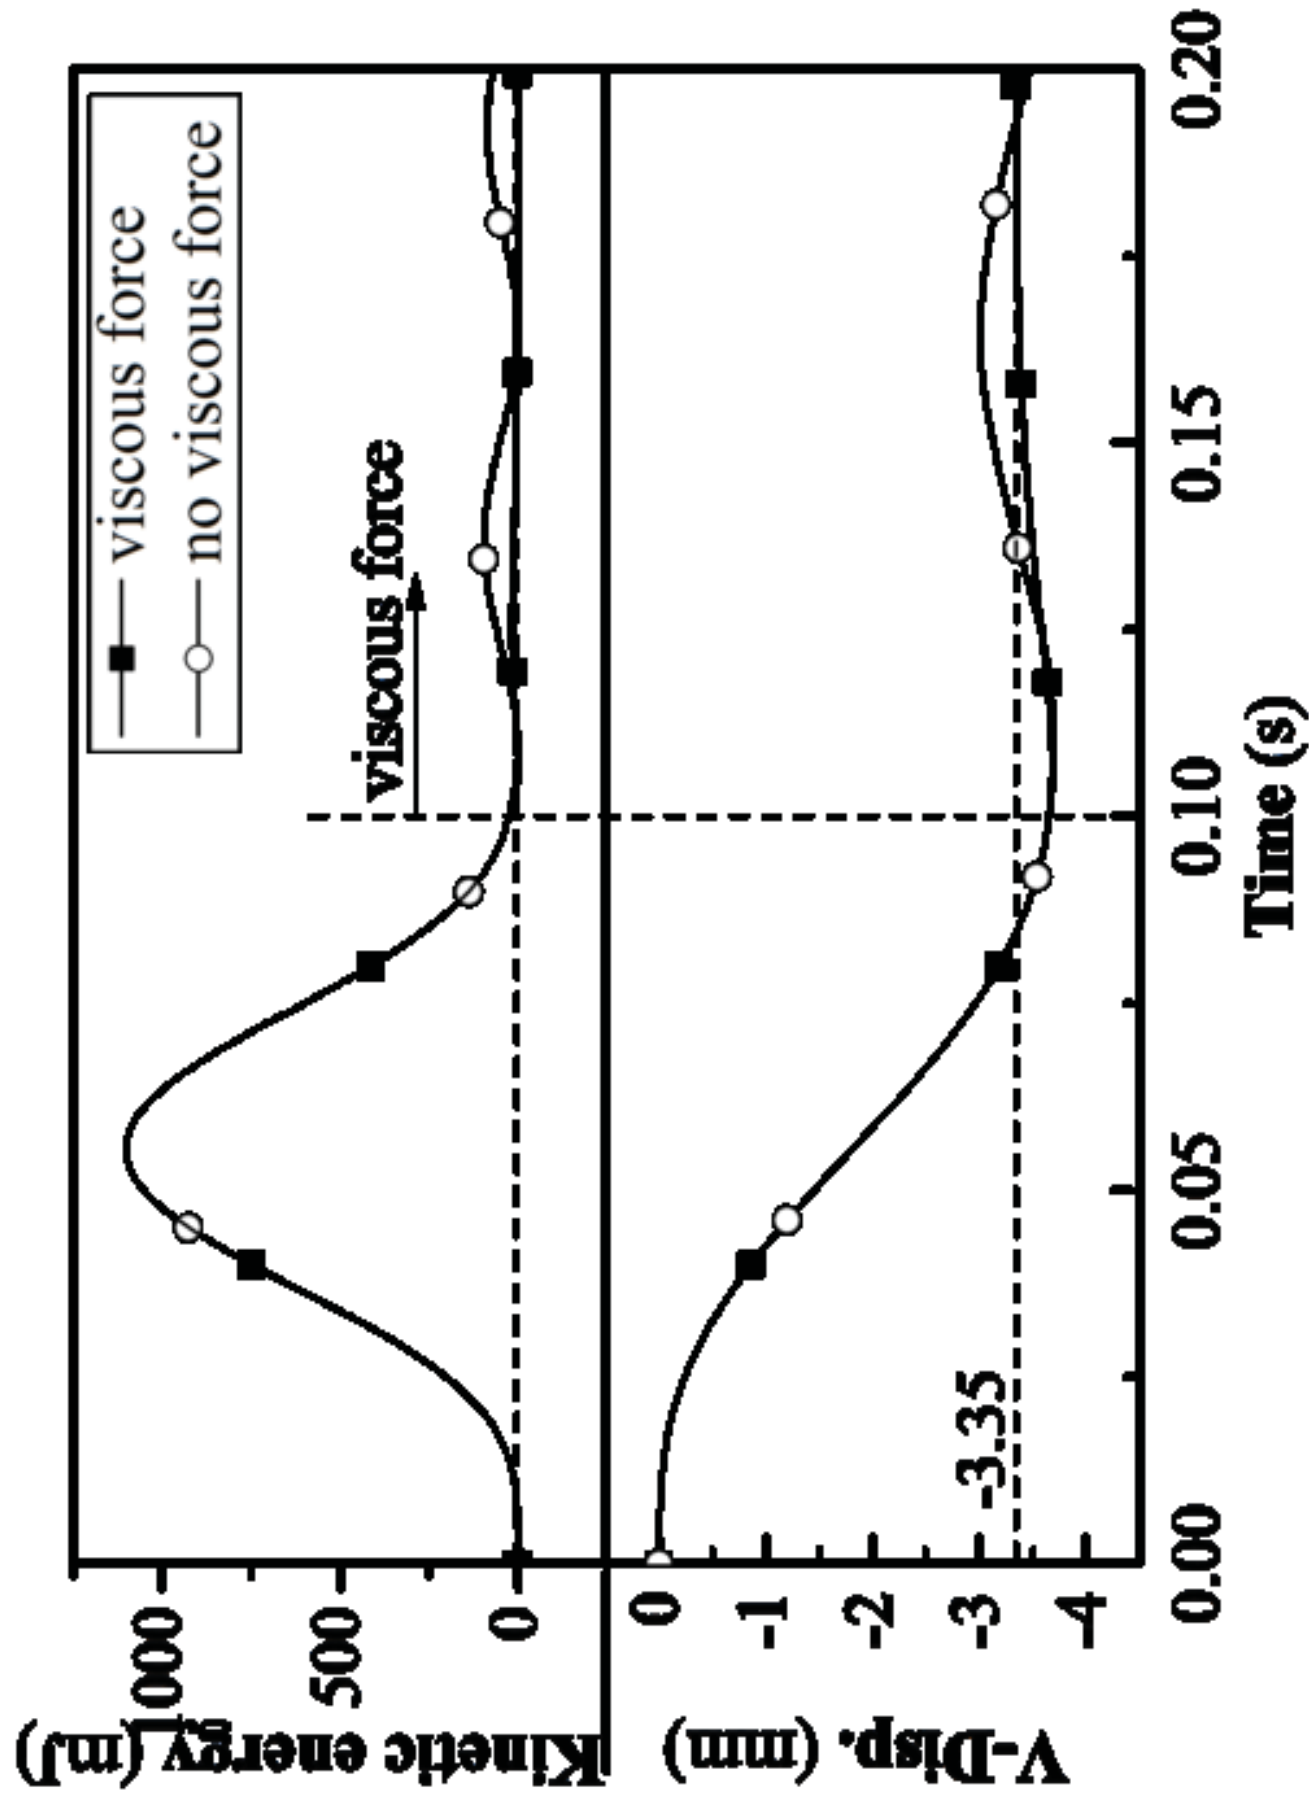
Fig 7

183 Fig. 6 shows the response of FE model of truss-PJ during the first step analysis. As can be seen, the kinetic energy of the  
184 whole model reduced to zero quickly after the application of the vertical viscous damping forces, and the vertical  
185 displacement at the mid-span stabilized at -3.35 mm which correlated well with the vertical displacement calculated by  
186 implicit analysis (ABAQUS/Standard). Hence, the scheme is deemed to be effective and the static balance of the truss-PJ  
187 model is achieved at the end of the first step analysis (in 0.2s). Fig. 7 presents the comparison between the FE results and  
188 the experimental measurements of the average axial strain of the removed member DM2. It can be observed that the  
189 removal of DM2 was well simulated in the FE analysis. This confirms that the proposed FE analysis procedure, which has  
190 been demonstrated in the previous two-bar model, works effectively also in the progressive collapse analysis of planar truss
